# Manhole Inspection Summary

Manhole # S29CC\_034MH

Insp Date: **1/12/07 10:55 AM**

**Location** Address: **442 DRUID HILL AVE**

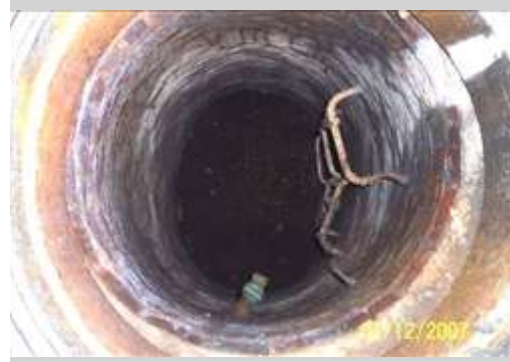
Top View

Corroded and missing steps. Evidence of surcharge - Channel debris.

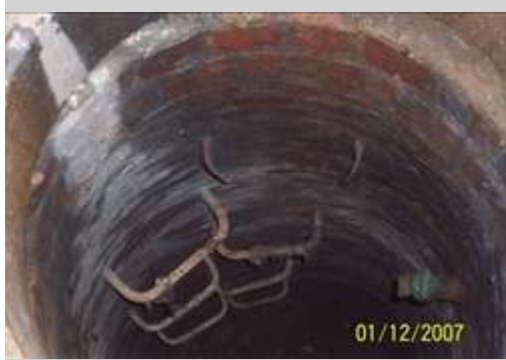
Defect

Frame leaks. Adjustment deterioration and infiltration. Corbel and Barrel infiltration - other side.

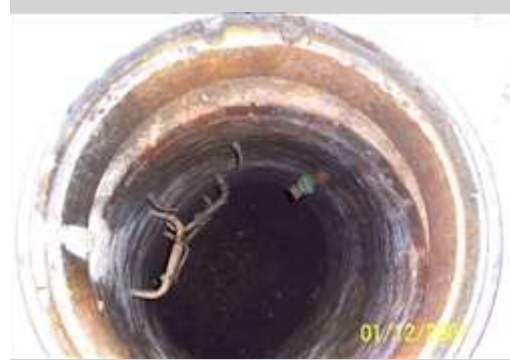
Defect

Frame leaks. Adjustment deterioration and infiltration. Corbel and Barrel infiltration.

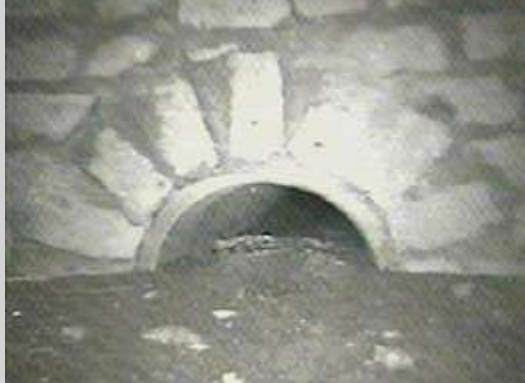
8 in. Circular Gravity Sewer  
Pipe Out @ 12 O'Clock

Deposits: ☐ None ☒ **Mud** ☐ Sludge ☒ **Debris** ☐ Grease

Silt Depth: **5** (in.) Deposits Extent: **Heavy**

Infiltration: **Evidence** Pipe Seal Cond: **Unknown**
